**DEPARTMENT OF TRANSPORTATION**

Contract #: 04-0120F4Cty: SF/ALA Rte: 80 PM: 13.2/13.9File #: 69.28**WELDING INSPECTION REPORT****Resident Engineer:**Pursell, Gary**Address:** 333 Burma Road**City:** Oakland, CA 94607**Report No:** WIR-001805**Date Inspected:** 26-Mar-2008**Project Name:** SAS Superstructure**OSM Arrival Time:** 600**Prime Contractor:** American Bridge/Fluor Enterprises, a JV**OSM Departure Time:** 1800**Contractor:** Zhenhua Port Machinery Company, Ltd (ZPMC), Changxing Island **Location:** Shanghai, China**CWI Name:** Sun Wei and Chen Chih-Ming**CWI Present:** Yes No**Inspected CWI report:** Yes No N/A**Rod Oven in Use:** Yes No N/A**Electrode to specification:** Yes No N/A**Weld Procedures Followed:** Yes No N/A**Qualified Welders:** Yes No N/A**Verified Joint Fit-up:** Yes No N/A**Approved Drawings:** Yes No N/A**Approved WPS:** Yes No N/A**Delayed / Cancelled:** Yes No N/A**Bridge No:** 34-0006**Component:** OBG deck panels and side panels**Summary of Items Observed:**

## WELDING INSPECTION REPORT

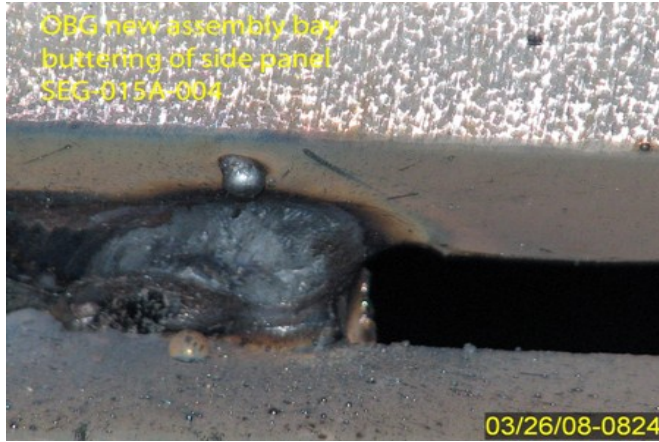
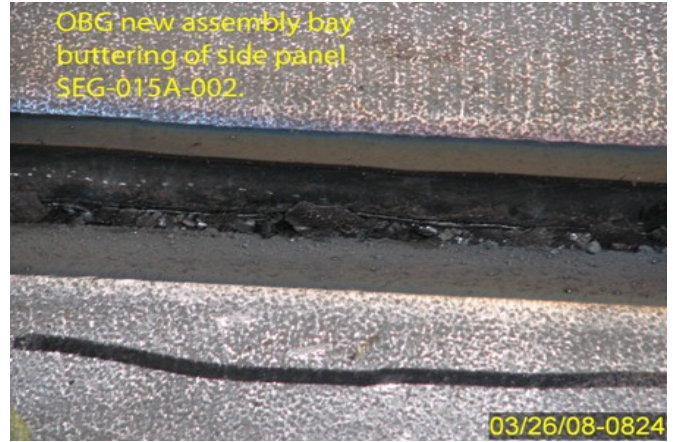
OBG new assembly bay

QA observed ZPMC personnel had already buttered (Built up with weld) the edge of side panel SEG-015A-002. QA noted that ZPMC did not break the panels apart to perform the procedure and they did not butter the entire edge surface, they only buttered the root in the areas that exceeded 6mm.(see attached photos) At the time QA departed this area ZPMC welding personnel was preheating side panel SEG-015A-004 in preparation for buttering of selected areas of the edge of one of the panels. NOTE: These panels were previously rejected due to excessive root openings refer to QA Steve Halls weld inspection report dated 3/25/08.
